Lessons from Texas City A Case History

Michael P. Broadribb, C.Eng.

Senior Consultant, Process Safety,
BP America Production Company,
Houston, Texas

American Institute of Chemical Engineers
40th Annual Loss Prevention Symposium

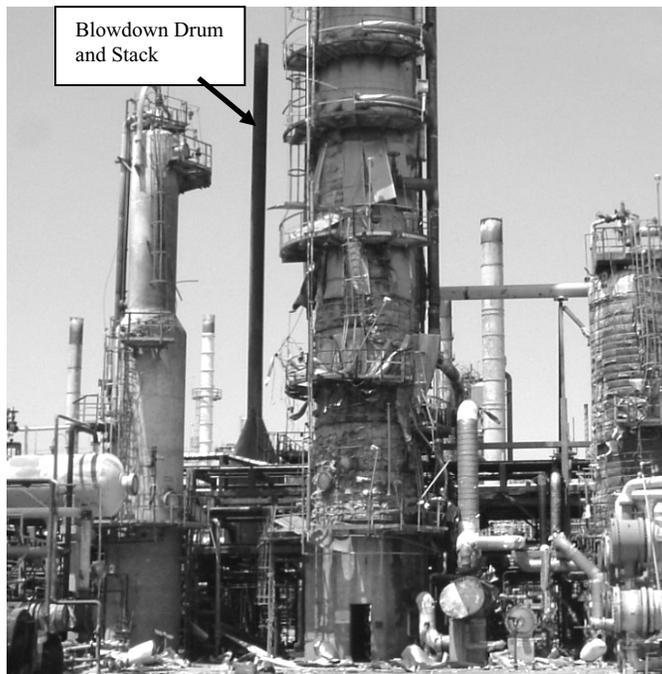
Hot hydrocarbon vapors and minor associated liquids from the ISOM relief, vent, and pump-out systems during upsets or shutdowns are disposed of to a blowdown system. The blowdown system consists of relief pipework headers (one of which is from the Splitter), the Blowdown Drum & Stack (F-20), and a pump-out pump. Vapors disperse from the top of the stack and liquids flow out of the drum through a gooseneck into the site's closed sewer system. F-20 was commissioned in the 1950s and has been modified several times over the years. It is a vertical drum of 10-ft diameter with a 113-ft-high stack.

Figure 3
Blowdown Drum and ISOM
Unit, After the Incident

- Begun the process to replace blow down stacks with flares
- Initiated a process to identify and stop nonessential work
- Engaged an outside firm to help assess and improve current maintenance work processes
- Conducting a review of span of control and focus of operations leadership roles
