Lessons from Texas City A Case History

Michael P. Broadribb, C.Eng.

Senior Consultant, Process Safety,
BP America Production Company,
Houston, Texas

American Institute of Chemical Engineers
40th Annual Loss Prevention Symposium

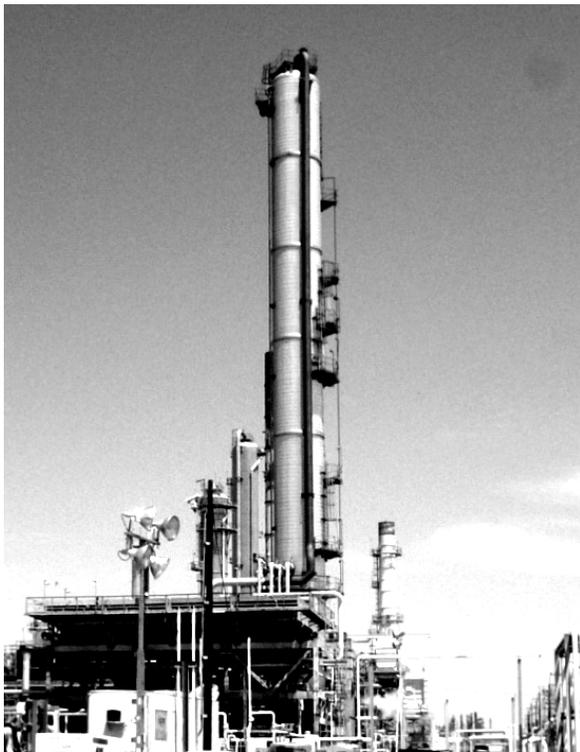
Figure 1
Raffinate Splitter

The Splitter was originally commissioned in 1976, but has been modified several times. It is a single fractionating column, 164 ft tall with 70 distillation trays, feed surge drum, fired heater reboiler, fin fan overhead condenser, and reflux drum. It has an approximate volume of 3,700 barrels, and processes up to 45,000 bpd of raffinate from the ARU. About 40% of the total raffinate fed to the unit is recovered overhead as C_5 / C_6 light raffinate. The remaining bottoms product consists of C_7 / C_8 heavy raffinate.

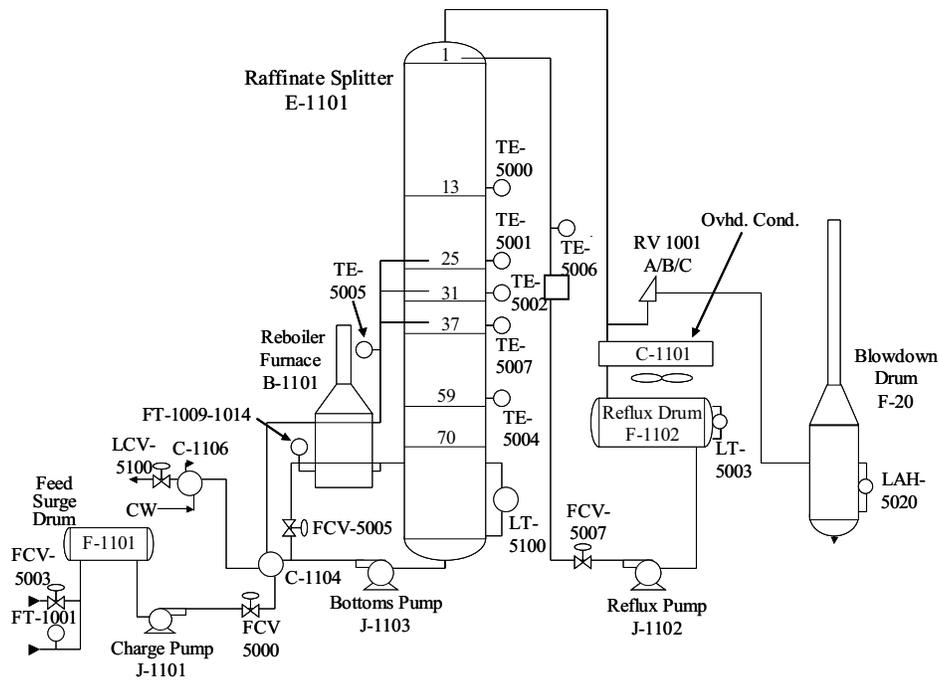
Figure 2 Flow Diagram of Raffinate Splitter

The incident occurred on the Isomerization Unit (ISOM) and involved the Raffinate Splitter (the Splitter), and Blowdown Drum & Stack. The ISOM converts low octane blending feeds into higher octane components for blending to unleaded regular gasoline. The unit has four sections, one of which is the Splitter, which takes a non-aromatics stream from the Aromatics Recovery Unit (ARU) and fractionates it into light and heavy components. The Splitter may be run in conjunction with the ISOM or independently to build inventory when the ISOM is shut down.
